108-40-10600 ROUTE CORRECTION

Stream: 108-40-10600 (cataloged for COp,Pp,DVp)

Date Surveyed: May 22 and June 3, 2013

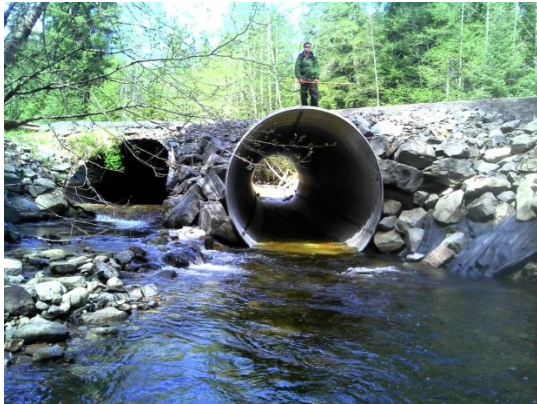
Findings: We surveyed stream 108-40-10600 and associated tributaries over the course of two days (Table 1). There are two large culverts under the Mitkof Highway which appear to be recently installed (Figure 1). The stream channel was shifted (Figure 2) and there were large buildups of debris in the outside curves of the creek which is evidence of a recent landslide in the creek. We stopped tracking the creek because the gradient increased and the substrate was large boulders making falls (Figure 3). There was no jumping or holding pools for fish.

Figure 1: Rick Hoffman standing on the outlet of the culverts.

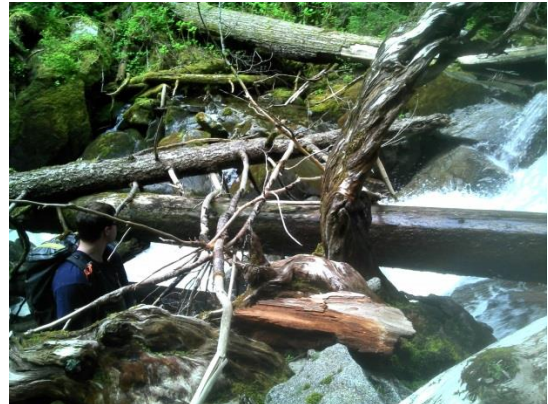
361	56.5594	-132.6459	Large rock and wood build-up, possible limit fish use upstream.		
362	56.5608	-132.6461	Calling it the top of the mainstem. Major gradient change with large boulders making falls. Right now possible velocity barrier and even more so at high water. No pools in falls for jumping.

Figure 3: Rick Hoffman in front of potential velocity barrier.

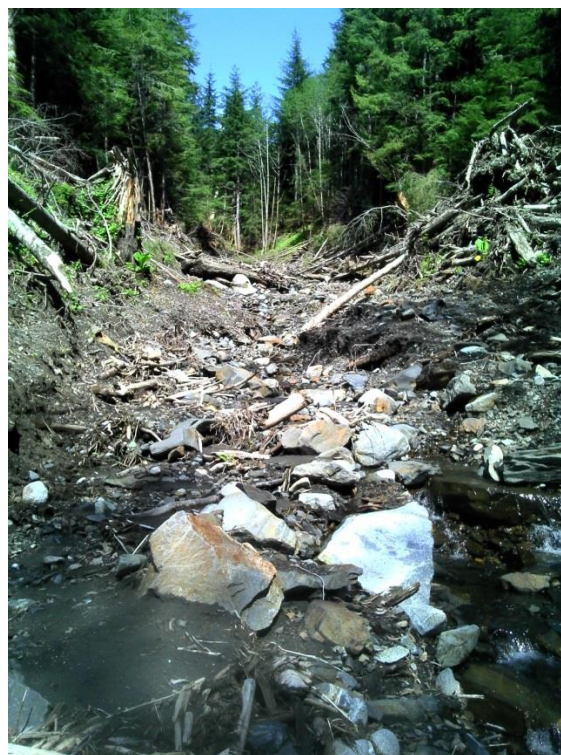
Figure 2: Old tributary channel that had been rerouted after landslide.
